# EVALUATION OF RISK AND POSSIBLE MITIGATION SCHEMES FOR PREVIOUSLY UNIDENTIFIED HAZARDS

William Linzey, Micah McCutchan, and Michael Traskos  
Lectromechanical Design Company

Richard Gilbrech, Ph.D.  
NASA Langley Research Center

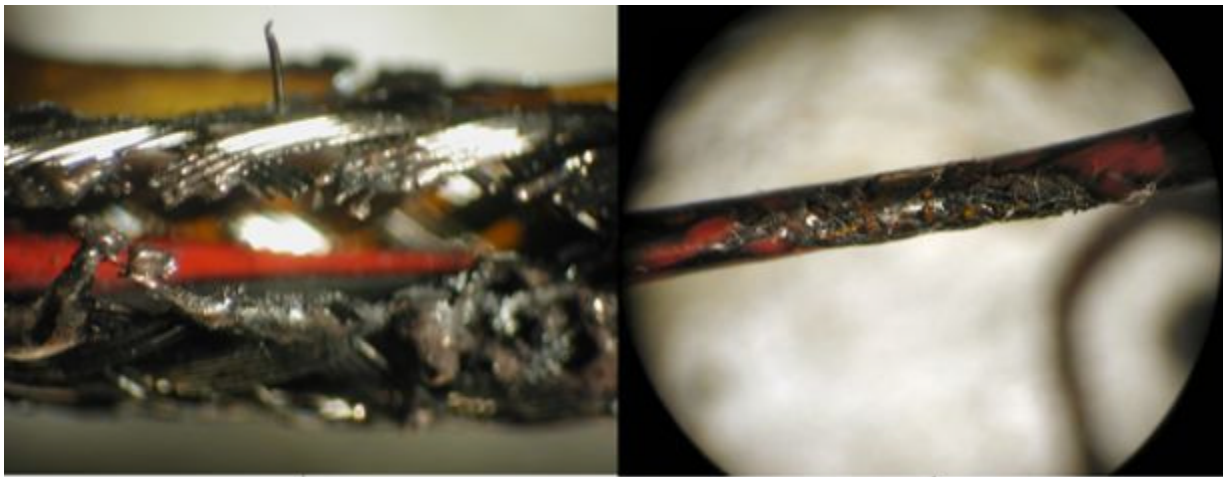
Figure 14a shows an example of a breach in the shield. Figure 14b shows damage to an inner fuel/ox wire at the point that it failed the wet DVW test. There is not an obvious breach exposing the conductor, but the insulation had been damage such that it could not prevent current conduction.

**Figure 14a. Close-up of Damaged Shield  
(Test Specimen 011)**

**14b. Photomicrograph of the Fuel/Ox Wire at the  
spot that it failed the wet DWV  
(Test Specimen 011)**
